2017 Hurricane Harvey Deployment  
Arkema Facility Response  
8/31/2017 1:45:27 PM

***2017 ASPECT Preliminary Report  
Arkema Plant Response  
Crosby, TX***

***August 31, 2017  
0600 hrs to 1300 hrs***

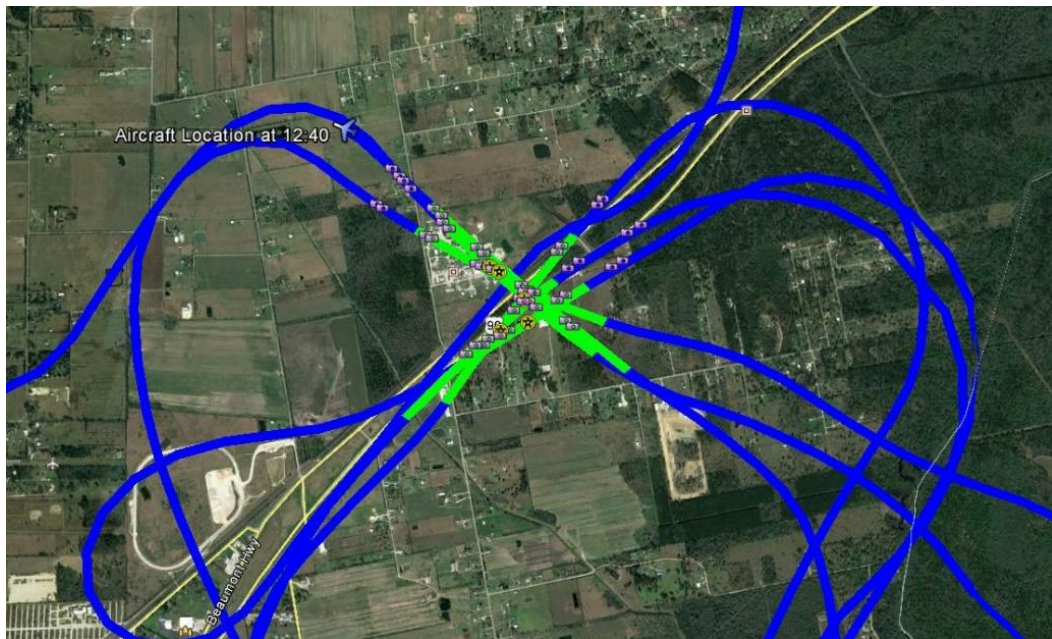
*Figure 7: Flight path over the facility at 0731 hrs CST (1231 hrs UTC) showing several passes where aerial imagery and IR sensors were active.*
